## Death Valley Floods

### October 18 Storm

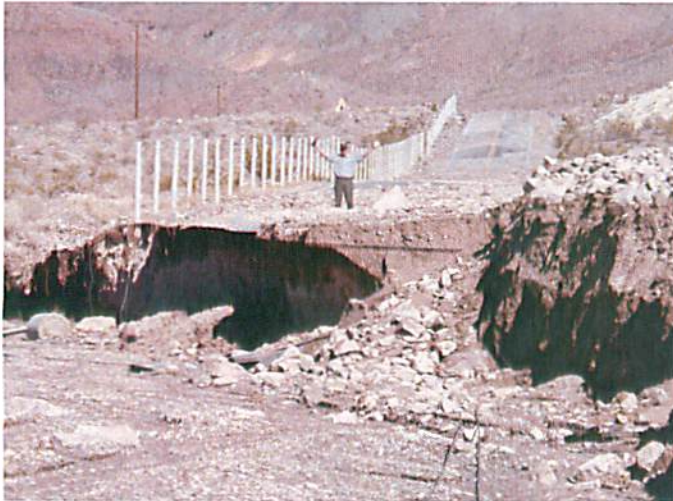
*Large sections of Scotty's Castle Road and historic fencing were destroyed.*

- Scotty's Castle Road is open from CA-190 to Ubehebe Crater, but closed through Grapevine Canyon to Scotty's Castle. Repairs will be funded and contracted by Federal Highways Administration and should start in 2017.
- Badwater Road is open from CA-190 to Harry Wade, but closed through Jubilee Pass to the gateway town of Shoshone. Repairs are in progress and should be complete by mid-July 2016.

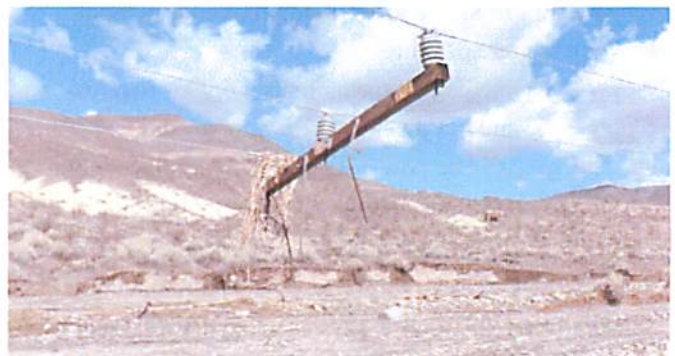
*24 power poles that supplied electricity to Scotty's Castle were washed away.*

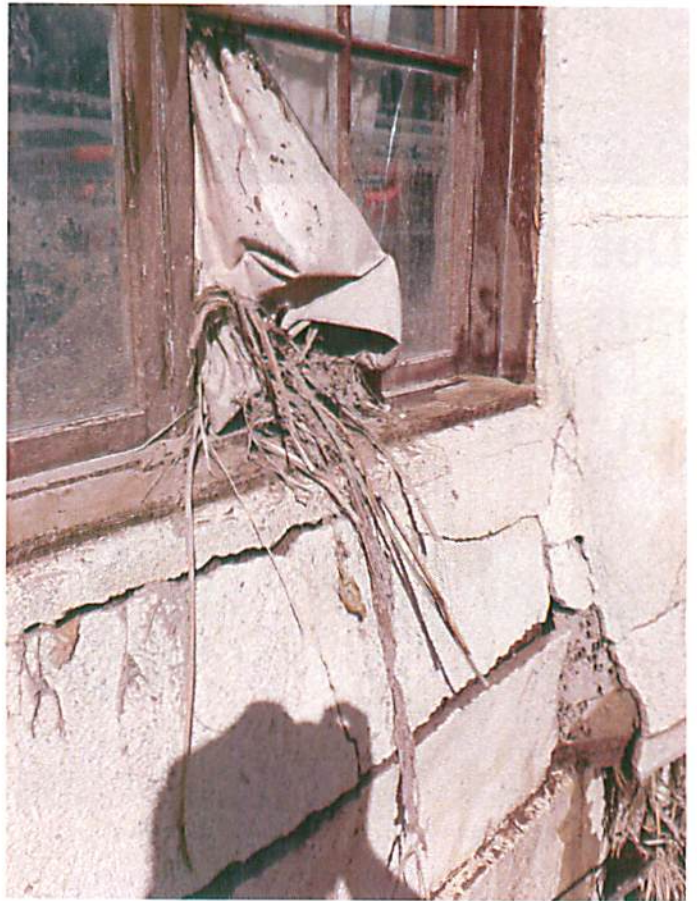
*The Visitor Center's south wall was punched out by the force of the flood inside the building. Another section of exterior wall was pushed 18 inches off the foundation.*

- Visitor Center ( historic Garage/Longshed): The flood broke doors, broke windows, broke interior walls, and smashed one exterior wall.
- Hacienda building: interior damage due mud up to four feet thick deposited inside.
- Scotty's Castle (Main House & Annex): The roof leaked in several places, allowing moisture into the building.
- Museum collection: The archives, furnishings, and other artifacts were threatened by lack of heating, air conditioning, humidity control and fire suppression and are being moved to temporary storage off-site.
- Water system: The spring house, one of two reservoirs, and the pipeline were destroyed.
- Electricity: The power line has been replaced, but electrical systems in and between the buildings need repair or replacement.
- Sewer: The leach field was extensively damaged.
- Historic Fence: Over a mile of historic concrete fence posts were washed away.
